Identifying Moisture Problems with IR Thermography

In moisture remediation, the first step is to find the source and correct the problem. Infrared thermography can detect the source of moisture even when it's hidden from view.

By Rafael Royo and Carla Montagud

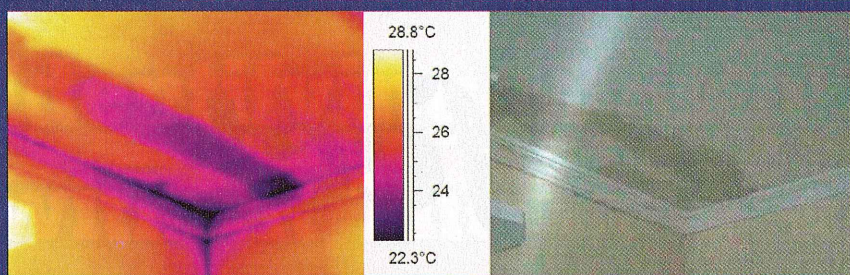
Thermogram and photo of a cold bridge causing condensation.

Figure 1 illustrates the effect of a huge "cold" bridge caused by both the metallic structure of the building and a complete lack of insulation.

The thermogram shows the position of the steel structure causing the condensation staining that appears in the digital photo. In this case, a partial repair is not possible, because condensation will appear again in the next closest cold area.

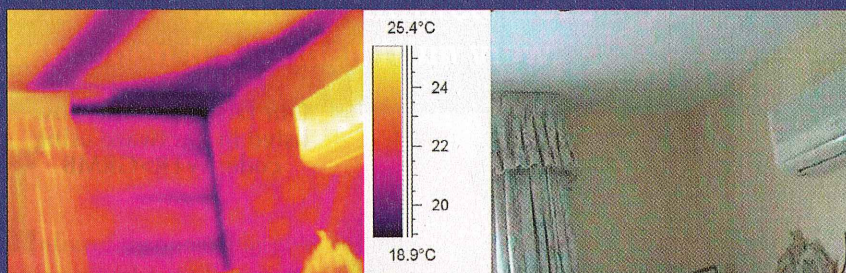
Figure 2

Thermogram reveals lack of insulation as evidenced by cooler pillars, beams and building blocks behind the walls, which causes condensation.

Sometimes the visual effects of condensation are not so dramatic, as shown in **Figure 2**. However, the thermogram reveals that this is probably a condensation problem. The shape

of the blocks in the wall can be seen due to a global insulation failure, along with very cold beams and vertical pillars.

It is also important to point out that the building owner uses a gas heating appliance during cool weather, which increases both temperature and absolute humidity. This makes condensation more likely.

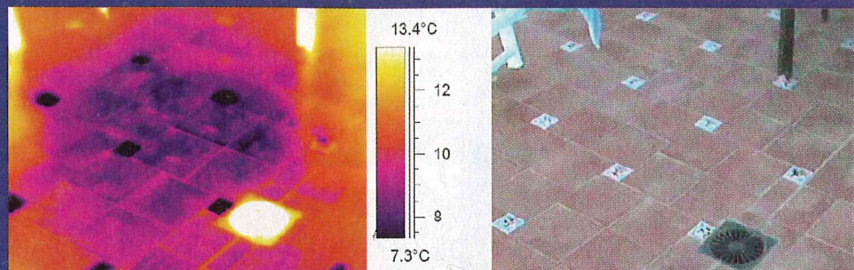
Figure 3 shows one of these cold zones on a roof terrace. Since the zone is near the rainwater drain, it's reasonable to assume cooling due to accumulated water from previous infiltrations. This may be the reason for so many damp spots on the underside of this building's roof.

Cold zone on a roof terrace, likely caused by water infiltration below the drain opening.

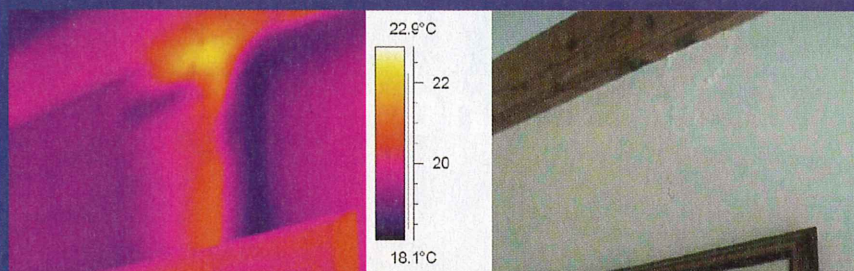
Figure 4

Thermography can also detect leakage from pipes and the pipes themselves. In one of the houses we inspected, the owner complained about moisture and mold growth in the walls. This appears as a raised pattern between the door frame and upper wood molding in the digital photo of **Figure 4**. The thermogram in that figure shows a yellow and blue vertical thermal pattern on the wall in the same area.

Thermogram and photo of an apparent moisture problem.

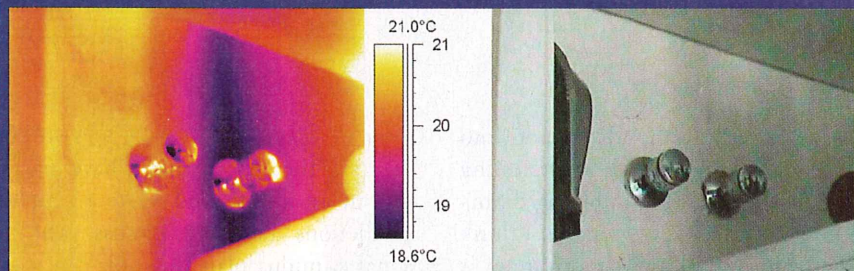
Figure 5

Next, we entered the room behind the wall shown in **Figure 5**, which turned out to be a bathroom. The reason for the moisture problem was evident when we focused the camera on this side of the wall. In **Figure 5** you can see the loca-

tions of the hot and cold water lines. Notice that the cold zone around the cold water line is more pronounced near the tap handle, i.e., there is a strong temperature gradient in that area. This tends to indicate leakage.
