Infrared Thermography as an Inspection and Maintenance Technique in Industry

Atílio Bruno Veratti
ICON Tecnologia
Sao Paulo, Brazil
abv@icontec.com.br

Erandy Flores Guevara
SERCA
Veracruz, Mexico
+521 9211549178, erandyfg@yahoo.com.mx

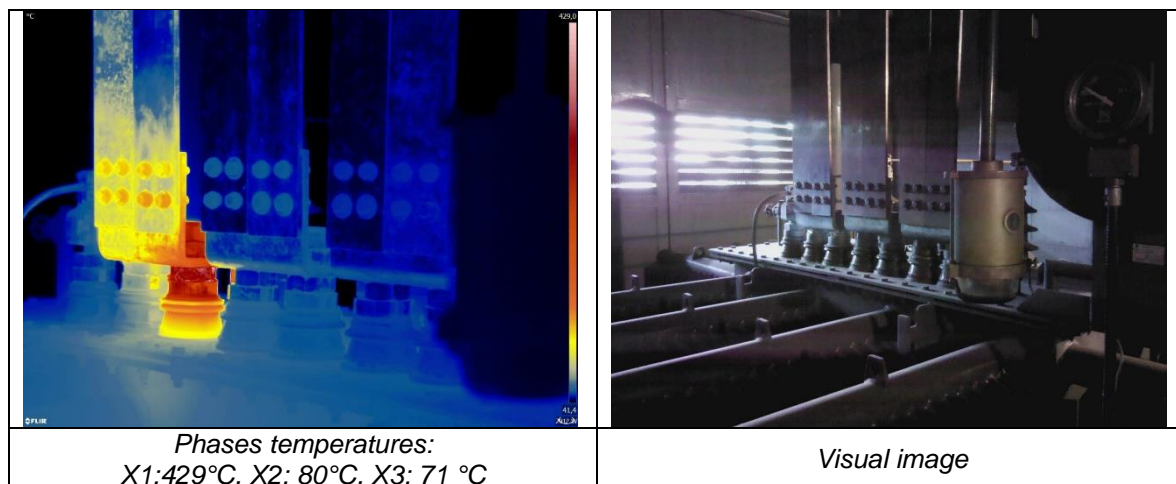
1st Anomaly: heating in the LV bushing terminal.

Figure 2. Thermal anomaly in LV bushing

The temperature in the X1 bushing, 429 °C, which already considers 90% of the nominal load, was actually lower during the inspection.

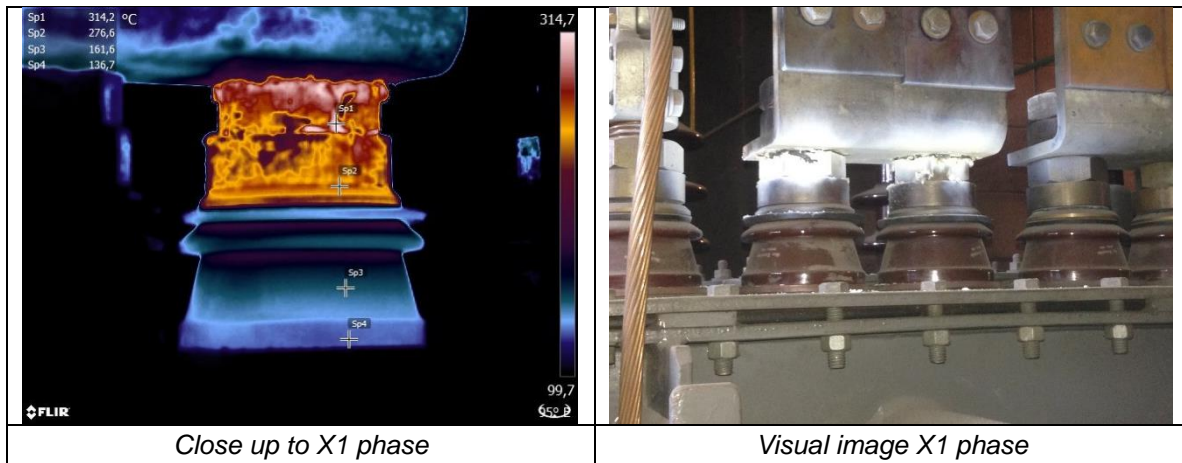
Observing the connections from a different angle allowed us to better appreciate their physical state.

Even though the gradient was pointing at the connection, the high temperature of the whole set did not exclude the damage in the interior of the transformer.

Figure 3. Close up of thermal anomaly in LV bushing terminal

The company took immediate actions, by dismantling the transformer.

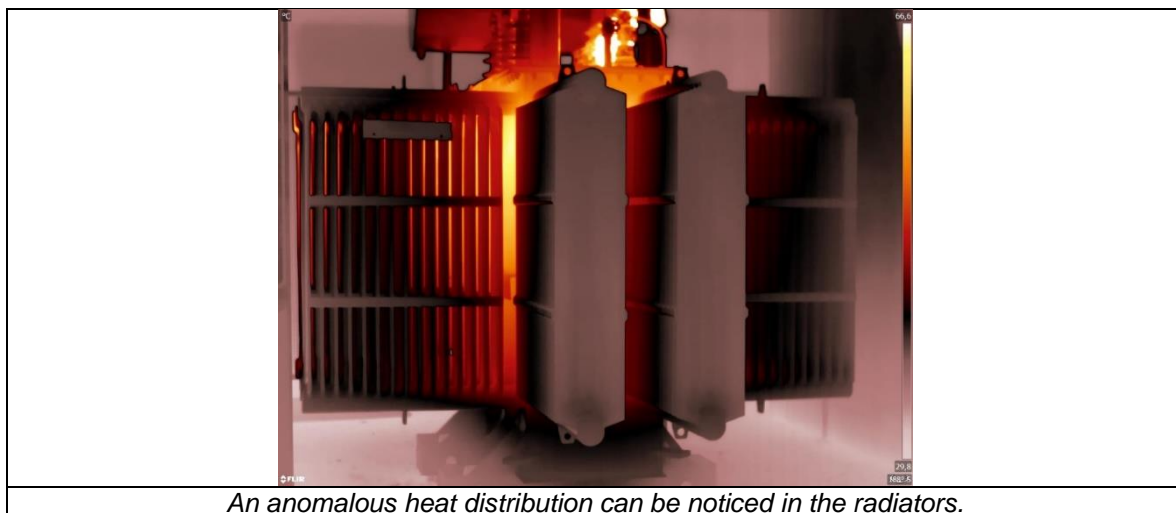
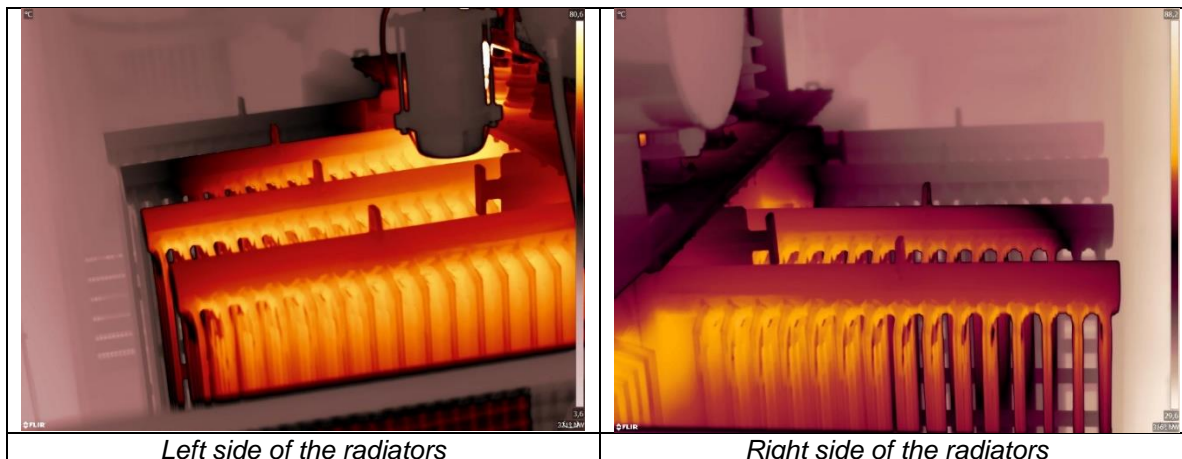
2nd Anomaly: low oil level evidence and deficient circulation in some parts of the radiators.

After investing some time in the plant, it was verified that the substation, where the analysed transformer remains, is located near the forging area. There are two machines with hammers, which caused a strong and repeated vibration on the ground, and this could have affected the transformer.

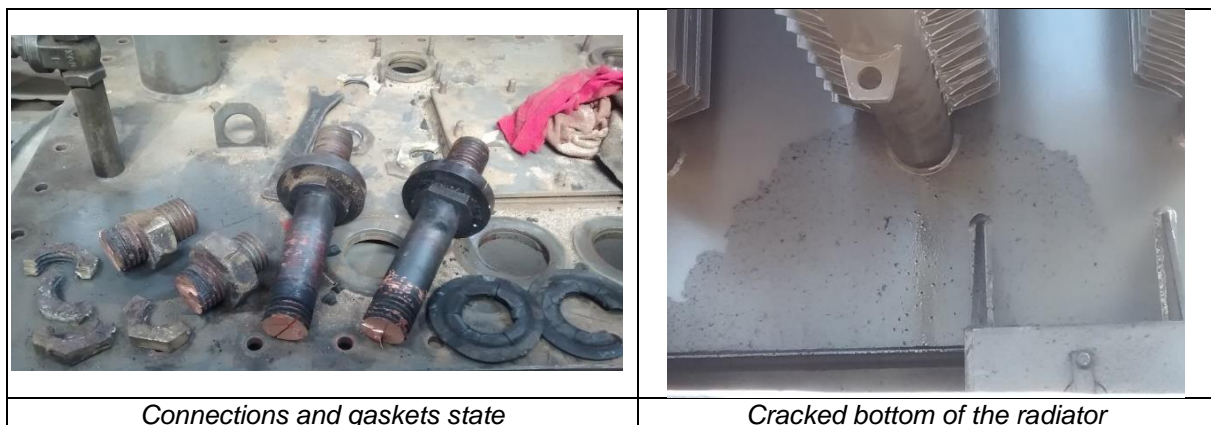
During the nuts and connections dismantling in the LV side, these were found melted, to such a degree that they had to be cut in order to take them off. Nevertheless, the low part happened to be loose since the nitrile rubber gaskets were burned.

The reason why there was a low level of oil was also identified. The weld at the bottom of one of the radiators was cracked, from where oil was leaking.

Figure 6. Physical state of the components with anomaly

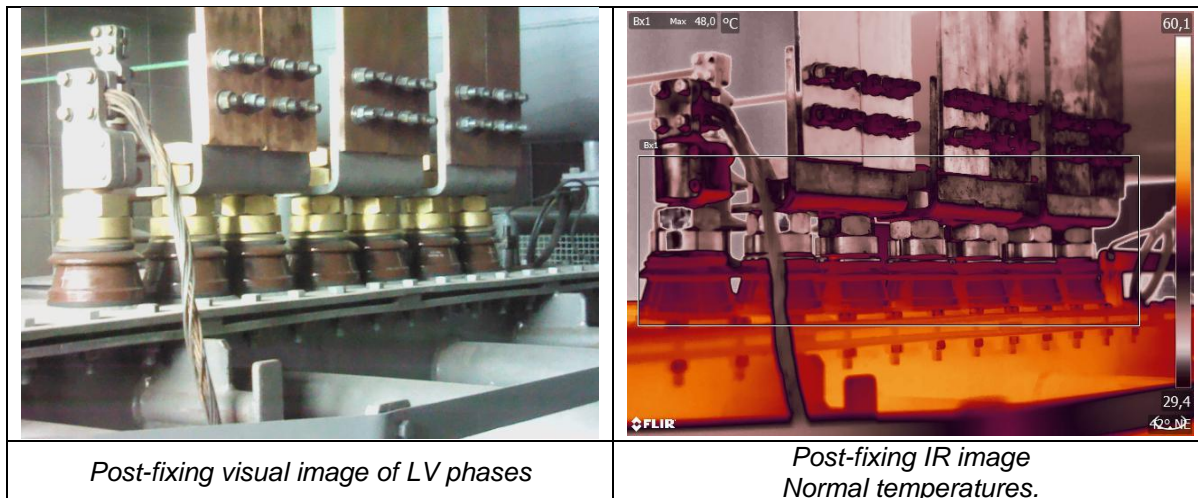
After assembling the transformer, a second thermographic inspection was carried out, finding normal temperatures and a total anomalies disappearance.

Figure 7. Verification of LV bushings

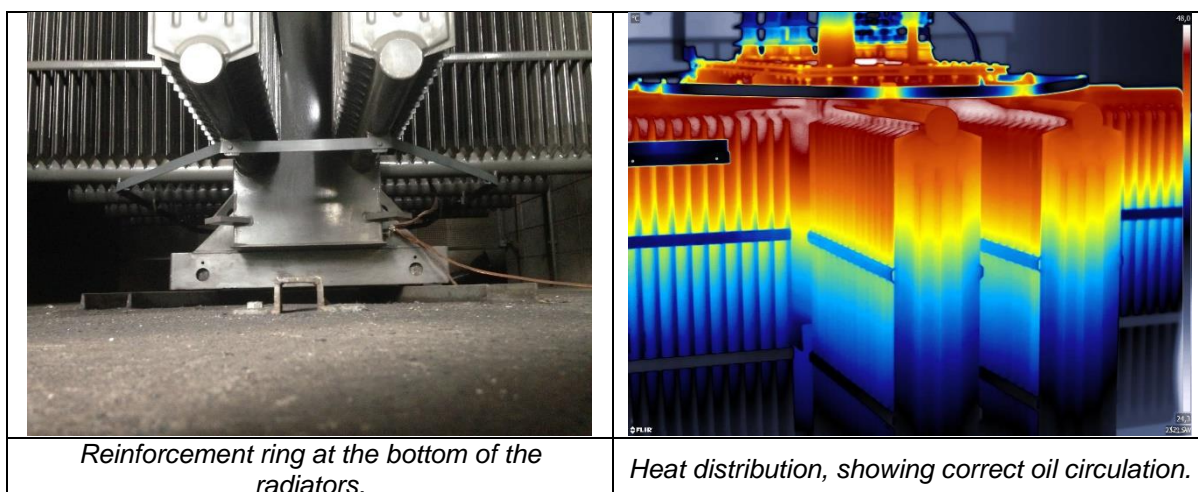
Figure 8. Verification of the transformer radiators.

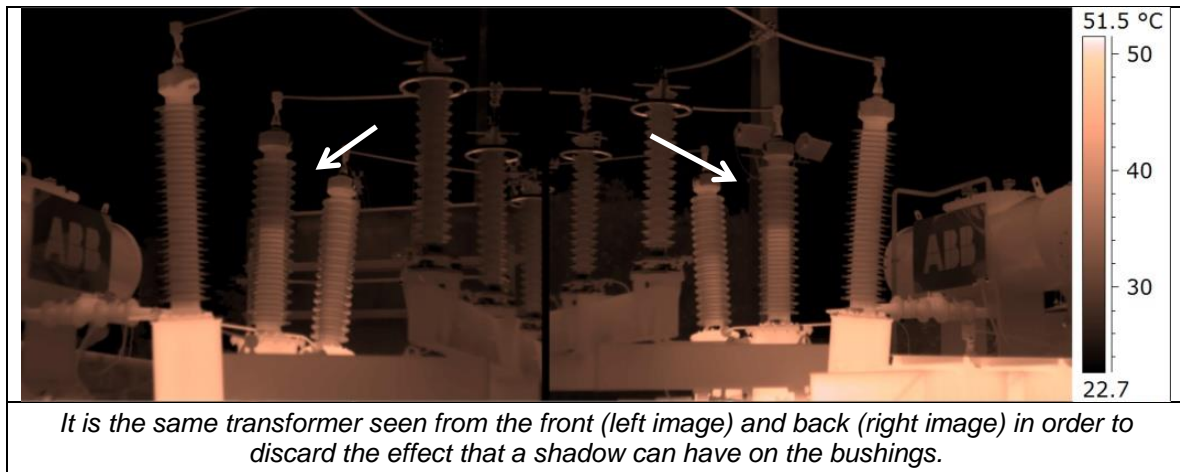
IR images show that the upper part of the central bushing (B phase) presents lower temperature than the rest of the body. This implies a low level of internal oil and a leak, which is very likely to flow inside the transformer's body.

Figure 9. The white arrows show the bushing with a low level of oil, B phase bushing.

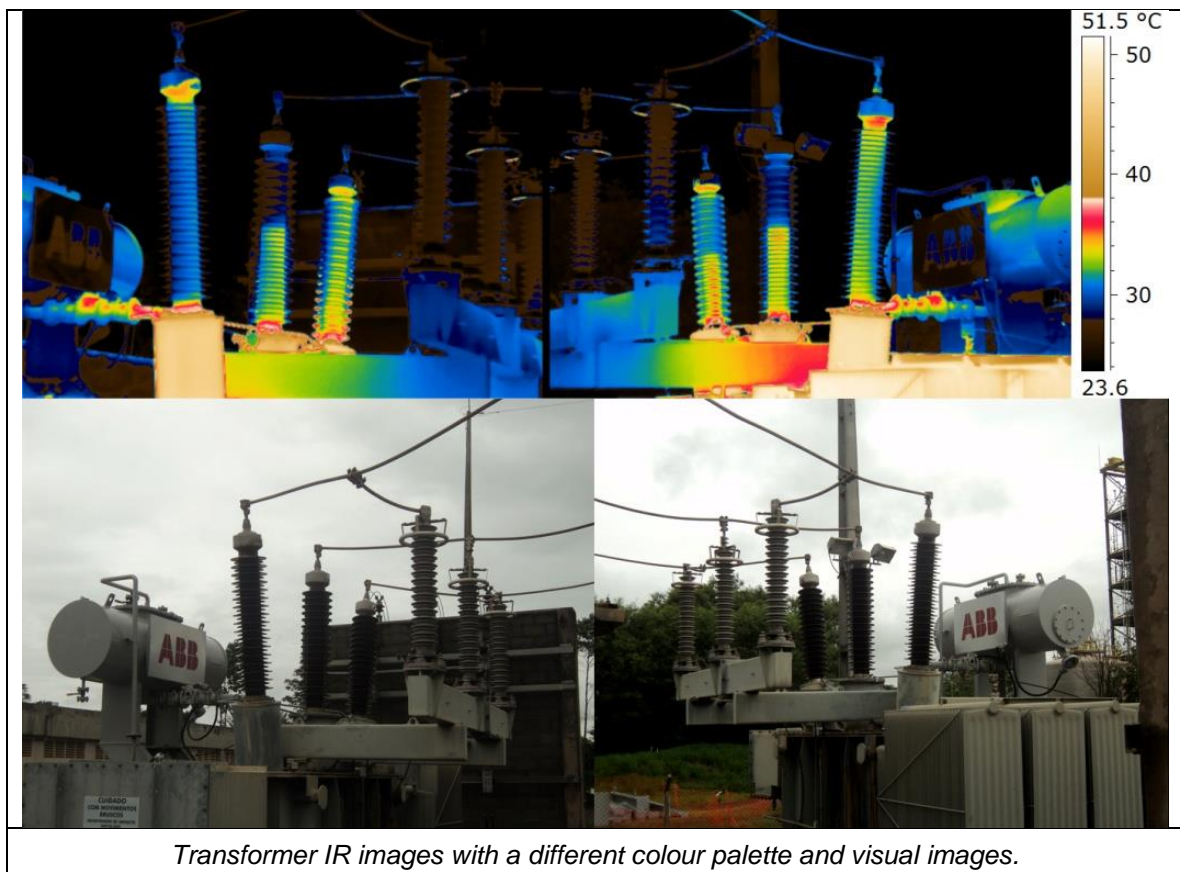
Figure 10. Thermal image of anomaly in B phase bushing using a high contrast palette.

It should be noticed that the thermal anomaly is determined by a little ΔT . It is easy to confuse it with the effect of a shadow on the element.

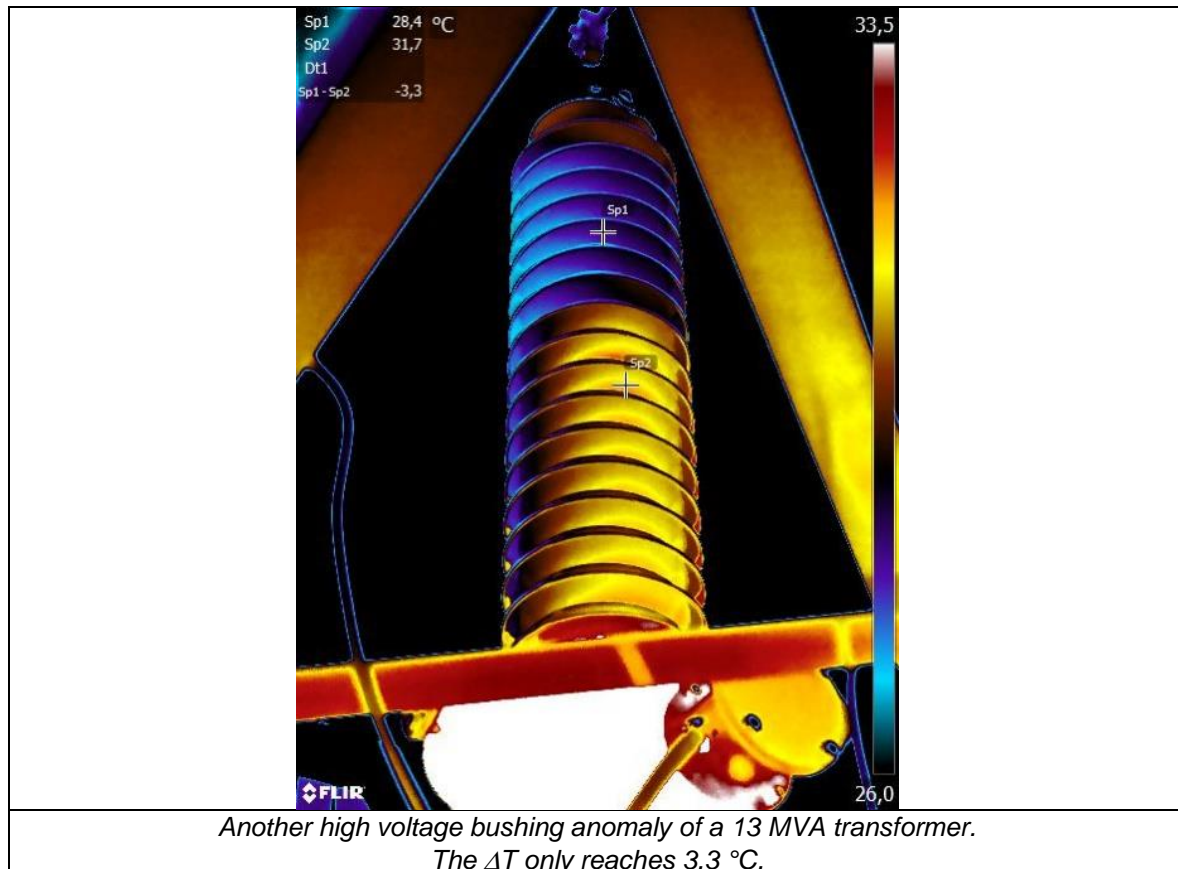
Figure 10. A second example of a thermal anomaly in bushing with a small ΔT .

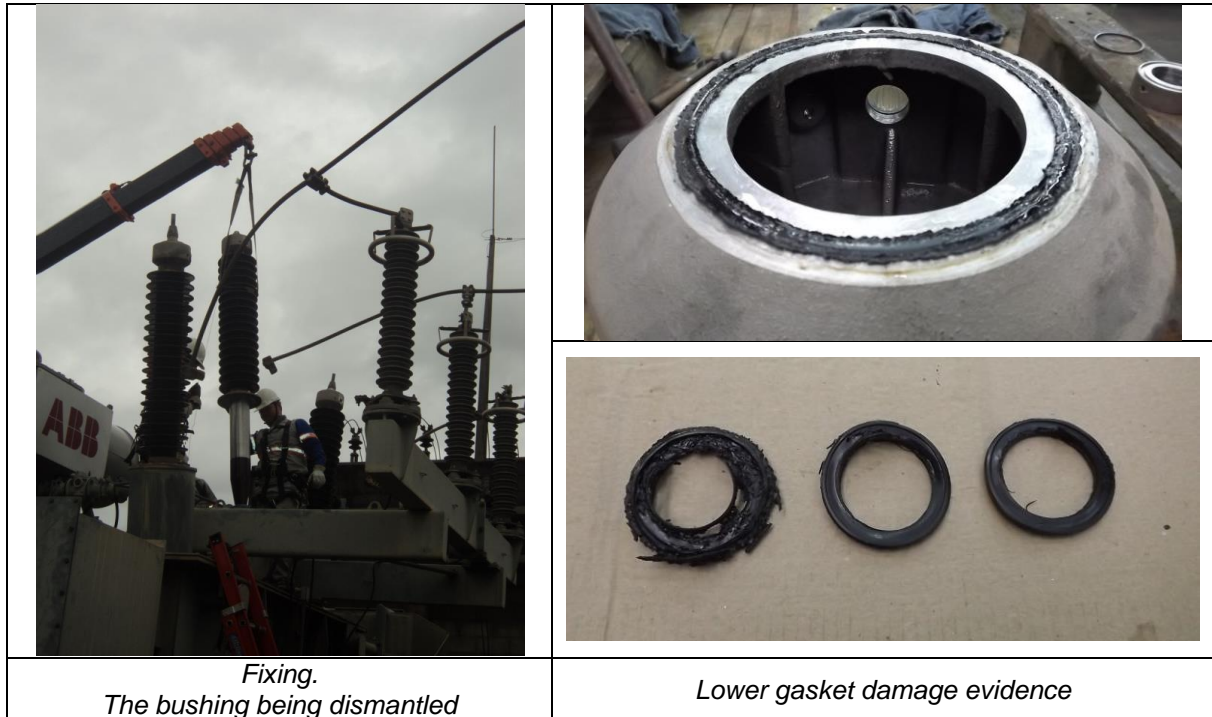
While the bushing was being dismantled, it was detected that the gasket at the bottom was damaged. Probably, this happened when the bushing was assembled during another maintenance service some time ago.

Figure 11. Physical state of the component with anomaly

Logistics measures were taken in a short period of time in order to solve the problem as quickly as possible.

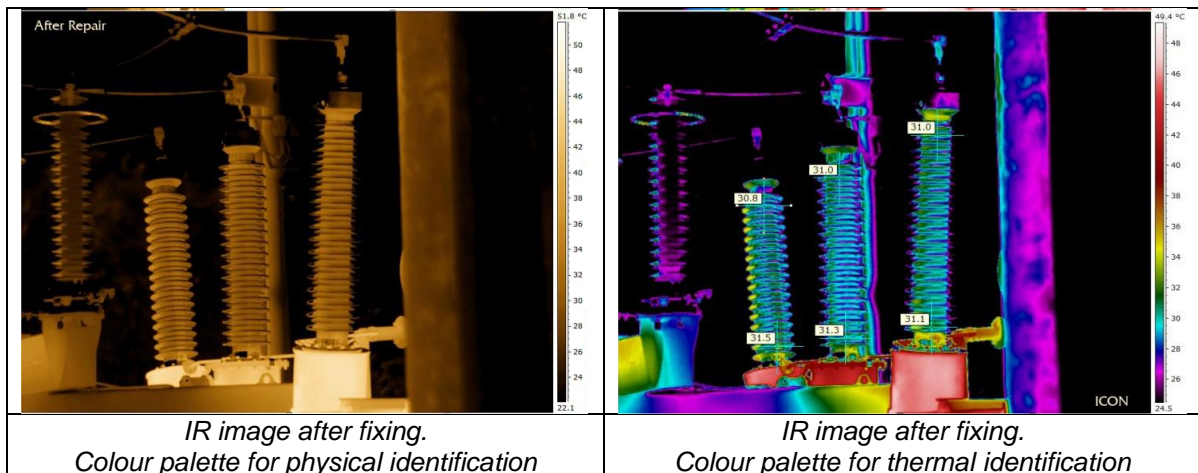
After the assembly, a second thermographic inspection was carried out, finding normal temperatures and the complete disappearance of the anomaly.

Figure 12. Verification thermal image.
