Thermal imaging helps to detect water ingress in airplanes

APPLICATION STORY

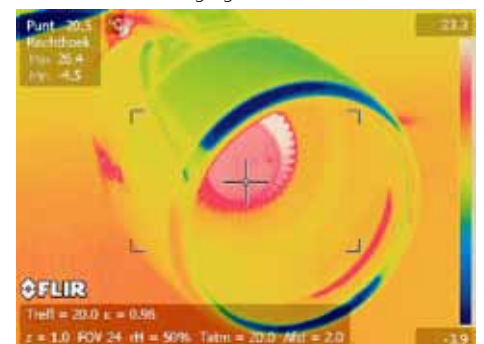
Thermal image of an engine; It takes expertise to "read" the thermal pictures of an airplane as different materials have different emission, resulting in different colors in the thermal image.

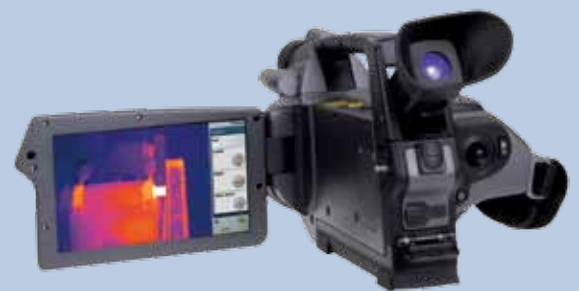
Specifications P660

- <30 mK sensitivity, accuracy +/- 1%
- Wide choice of optics
- 8x digital zoom
- Extended measurement functions
- Advanced Laser Pointer
- Set temperature alarms
- USB and Firewire connection
- Radiometric and non-radiometric video recording
- Sequence recording in camera
- Built-in GPS
- Contrast Optimizer

produces crisp thermal images of 640x480 pixels on which the smallest of details can be seen. The camera allows seeing temperature differences as small as 0.03°C. Not only does the FLIR P660 has a super size 5.6" foldable high-quality LCD screen, it also has a viewfinder which can be extremely easy to do inspections in summertime and the sun is shining on the LCD display."
