Inspection for Ice or Water in Honeycomb

System for Inspection of Fuselage

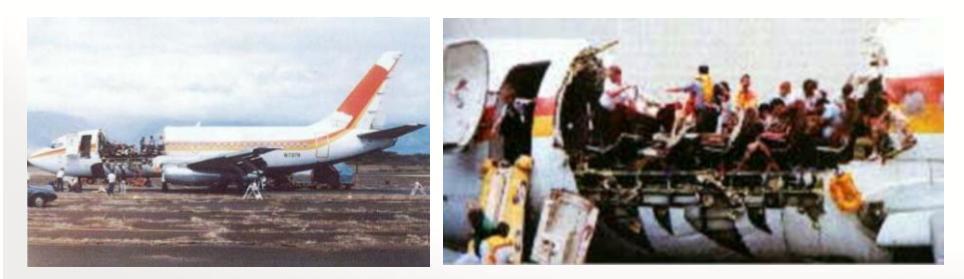
The ALOHA Incident

On April 28, 1988, at 1346, a Boeing 737-200, N73711, operated by Aloha Airlines Inc., as flight 243, experienced an **explosive decompression and structural failure at 24,000 feet**, while en route from Hilo, to Honolulu, Hawaii.

Approximately 18 feet of the cabin skin and structure aft of the cabin entrance door and above the passenger floor-line separated from the airplane during flight.

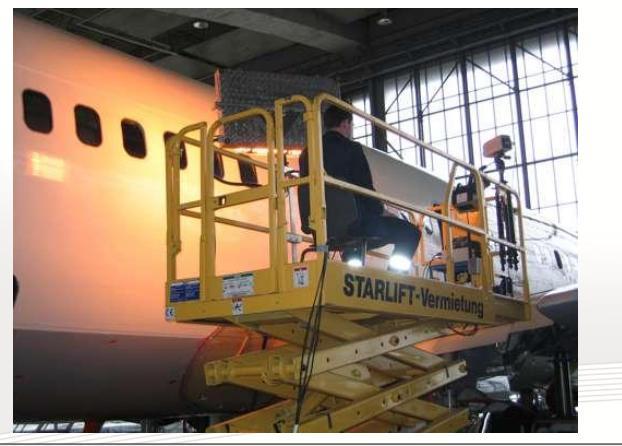
Defects like delaminations, loose rivets or water inclusions can be reliably detected within short time.

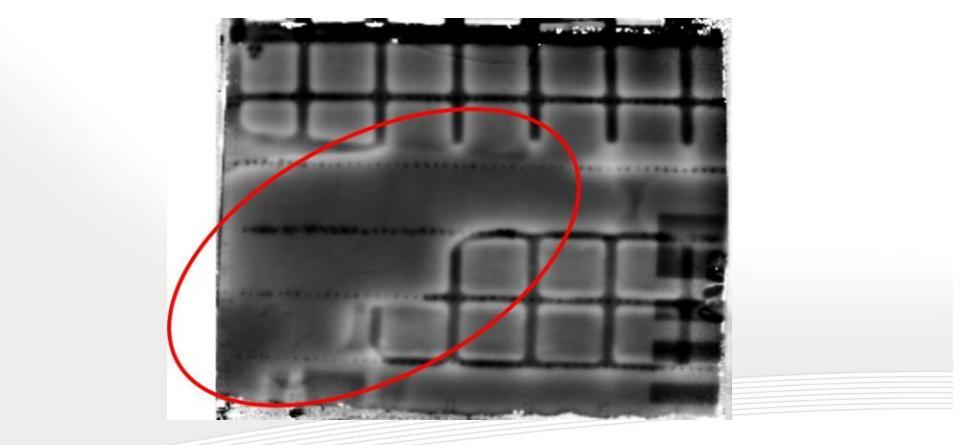
Inspection of Fuselage

Test panel (section of B737 fuselage): Large area disbondings can be clearly Identified in the result image

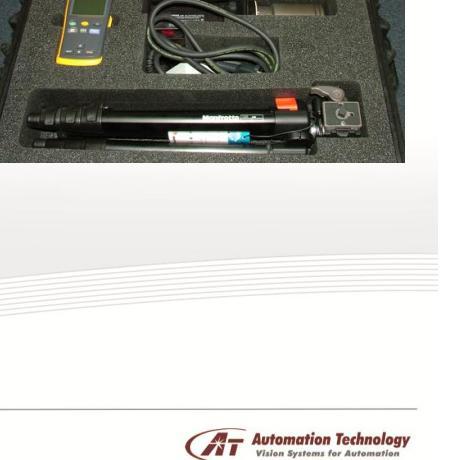
JetCheck Fuselage Inspection of Disbonds in bonded Aluminium Structures, e.g. disbonds between fuselage skin and doublers Applicable to:

- Boeing Procedure 737 NDT, Part 9, 51-00-04 and 53-30-01
- Aircraft: B737-200, -200C, -300, -400, -500

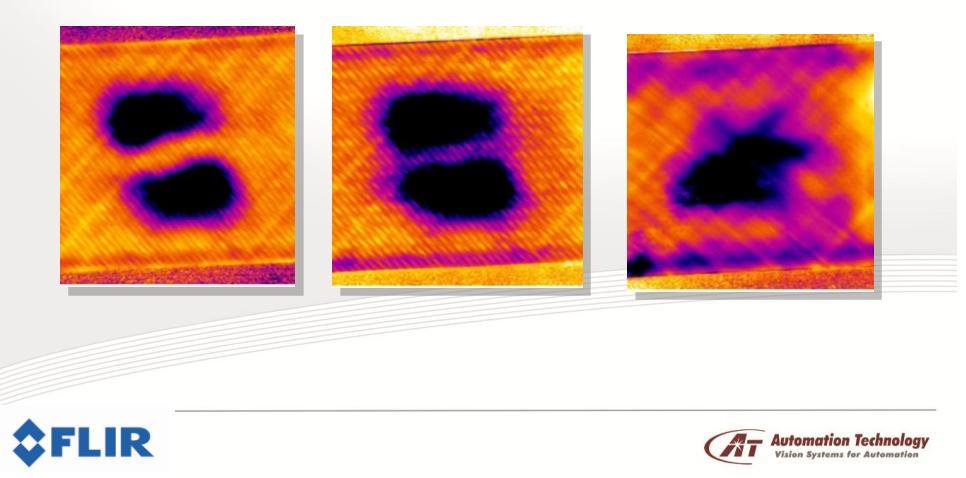
Impact Damage in CFRP

Delamination in CFRP due to mechanical impact shown at different depth. Near surface -> rear surface

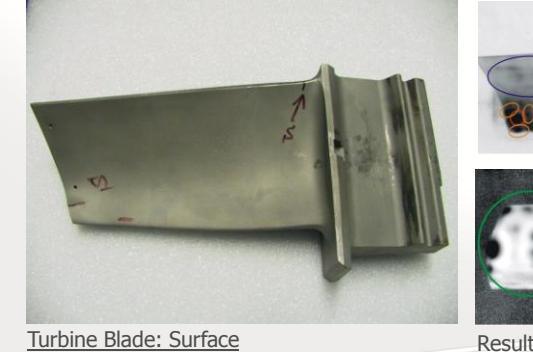
Turbine Blade: Surface (cracks are marked)

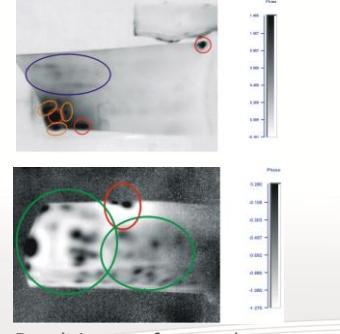
- Result images front and rear: - Indications from surface cracks are marked red
- All other indications are caused by hidden cracks or clusters of micro-cracks

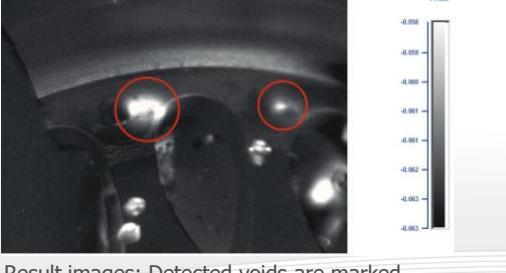
Crack Detection in Wheels

Result images: Detected voids are marked
